Evaluation Report 295

Co-op Implements 1001 Disker

ALBERTA
FARM
MACHINERY
RESEARCH
CENTRE

CO-OP IMPLEMENTS 1001 DISKER

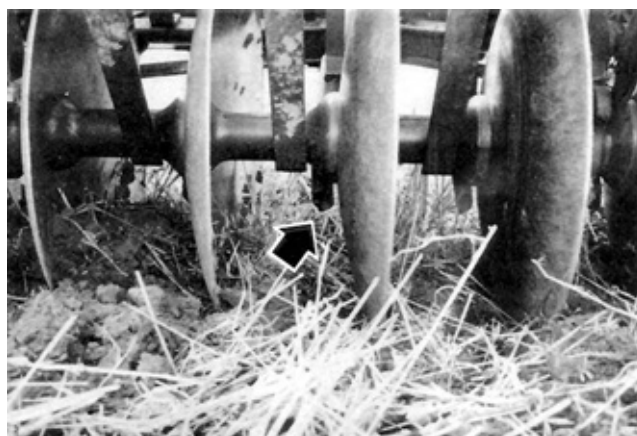
FIGURE 3. Seed Tube Position.

Seed Placement: Seed placement was good in most field conditions. The seed tubes were positioned behind the disk (FIGURE 3) to place the seed at the bottom of the furrow. At 8 km/h (5 mph), most seeds were placed within 13 mm (0.5 in) of the average seed depth. Some seed scattering occurred at higher speeds and depths greater than 76 mm (3 in). In the bottom of ravines or gullies, seed was placed on the soil surface as the disks were unable to follow variations in ground contour.

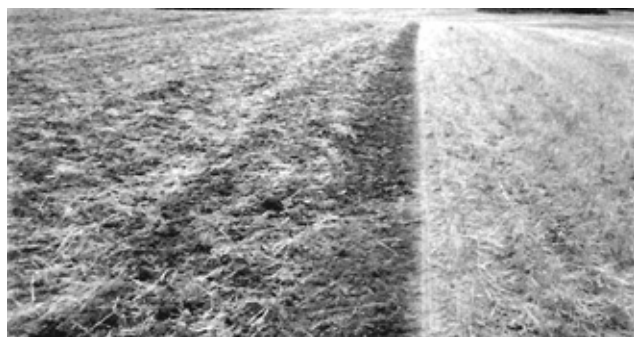
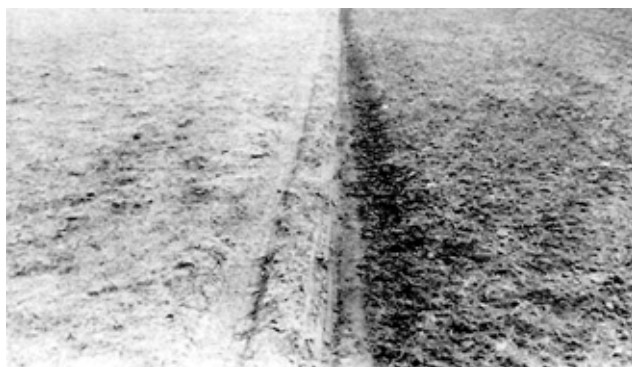
FIGURE 4. Soil Surface after Seeding into Stubble: (A) Heavy Trash Cover, (B) Light Trash Cover.

Ridging: The CI 1001 usually produced an even seedbed with a uniform soil surface (FIGURE 4) provided it was properly adjusted. The centre furrow wheel lock stabilized the centre furrow wheel and reduced untilled strips or overlapping between the front and rear units on steep hillsides. Slight furrow bottom ridging occurred on hillsides and gradual left turns as the width of cut increased. Furrow bottom ridging decreased with narrower widths of cut. A width of cut 10% less than the nominal width of cut is recommended for seeding to obtain a good weed kill and to provide a uniform furrow bottom for seed placement. At speeds above 11 km/h (7 mph), bouncing of the disk harrow produced an uneven seedbed.

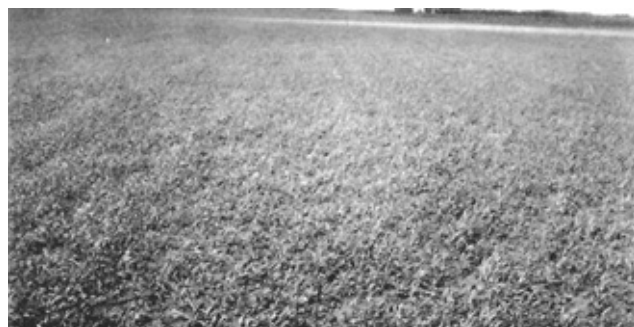
FIGURE 5. Neepawa Wheat 23 Days after Seeding into Stubble. Moisture Conditions Good.

Plant Emergence: Plant emergence was uniform (FIGURES 5 and 6) in all fields with sufficient moisture and nutrient reserves. Emergence was delayed in hard or dry soils.

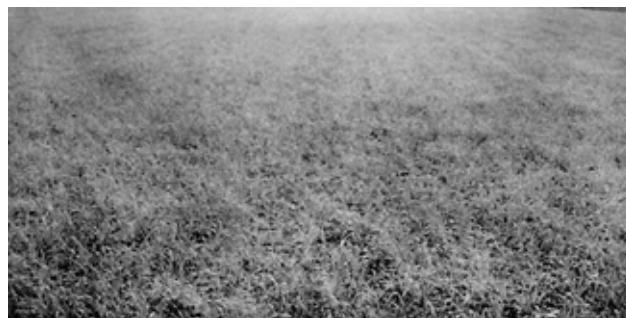
FIGURE 6. Klages Barley 24 Days after Seeding into Stubble. Moisture Conditions Good.

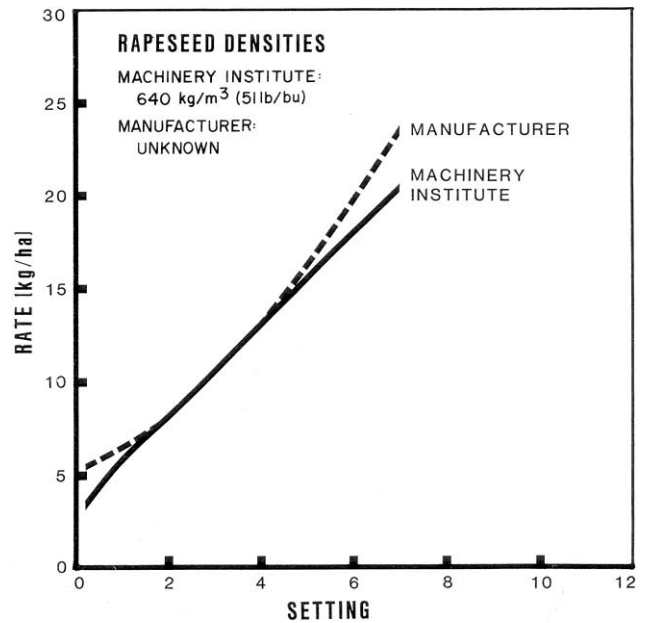
FIGURE 9. Rapeseed Calibration.

Seed metering system accuracy was very good in wheat, barley, oats and good in rapeseed. The manufacturer's calibration charts for wheat and barley were the same as the Machinery Institute's calibrations. Some differences were obtained between the manufacturer's calibrations and the Machinery Institute's calibrations for oats and rapeseed (FIGURES 8 and 9). Differences in seeding rates will occur when using seed of different size, density and moisture content or when operating at different widths of cut. To obtain exact seeding rates, it is important to adjust for different seed properties and widths of cut.

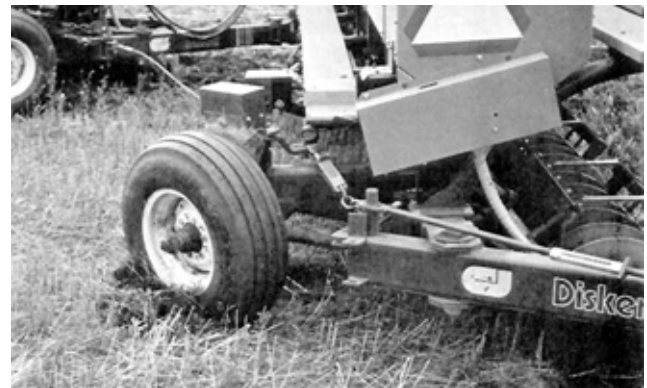
FIGURE 11. Skidding of the Rear Land Wheel when Making Sharp Left Turns.

Turning: Left 90° turns were easily made. Sharp left turns greater than 90° caused skidding of the rear land wheel (FIGURE 11). Tilled corners were smooth and could easily be covered by two passes when finishing the field. Sharp right turns had to be made with caution due to interference between the tractor tire and the front unit. When making right turns, the gangs should be raised to reduce draft and prevent possible disk damage in stony fields.

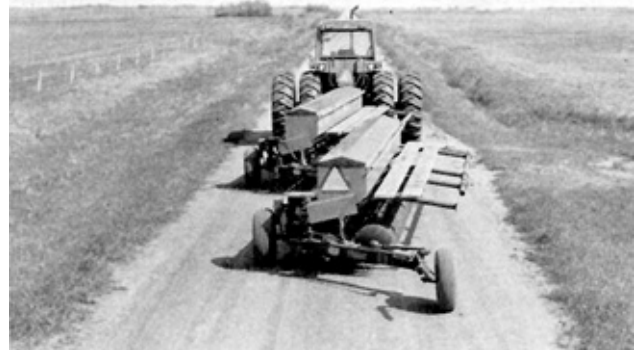
FIGURE 12. Full Transport Position.

Transporting: The CI 1001 could be safely transported at speeds up to 34 km/h (21 mph) when in full transport position, providing the seed and fertilizer boxes were empty. It could be put into or taken out of full transport by two men in about 30 minutes. A jack and adjustable front hitch made hitching to the tractor easy. A lock on the hydraulic cylinder prevented the disk gangs from being lowered while transporting. Damage could not occur when the hydraulics were activated with the lock engaged. Transport width was narrow enough to allow most vehicles to pass on secondary roads (FIGURE 12).

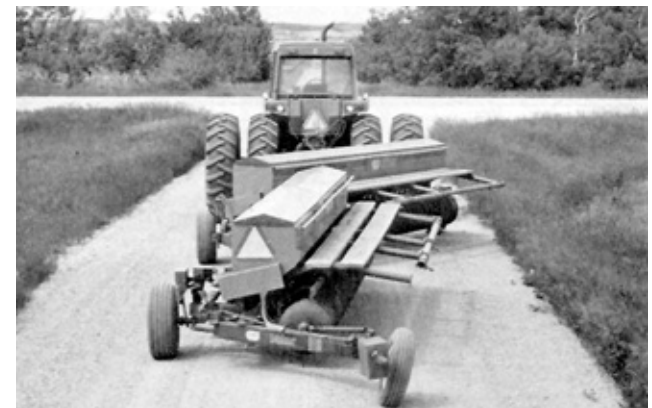
FIGURE 13. Semi-Transport Position with Hitch Brace Collapsed.

The CI 1001 could be safely transported at speeds up to 30 km/h (19 mph) in semi-transport. Semi-transport width with the hitch brace collapsed was narrow, making transport on secondary roads safe and easy (FIGURE 13). The CI 1001 could be placed in or taken out of semi-transport by one person in about 5 minutes. Wheel lead adjustments for semi-transport did not affect field settings. Right or left turns were easily made in semi-transport.
